Patient Safety Alert

AL09-22

June 8, 2009

Items: Physician Advisory issued by Medtronic Inc. on subsets of: Kappa 600/700/900 series dual chamber and single chamber pacemakers and Sigma 100/200/300 series dual chamber and single chamber cardiac pacemakers

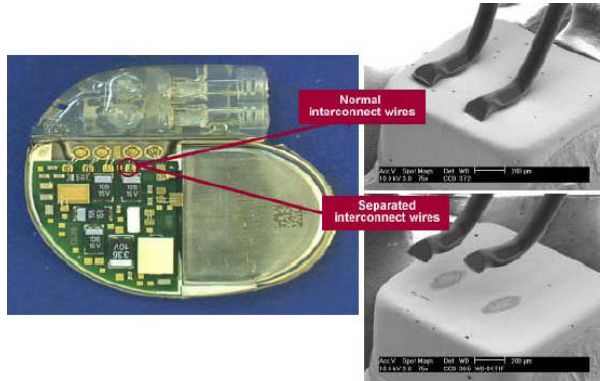
Specific Incident: Medtronic is reporting loss of rate response; premature battery depletion; intermittent or total loss of telemetry; or loss of pacing output in a subset of Kappa and Sigma cardiac pacemaker units. The cause of the failure has been identified as separation of redundant interconnection wires from the hybrid block in the pacemaker circuit (i.e., loss of contact). Predicted failure rates are 1.1% and 4.8% respectively, for Kappa 600/700/900 series and Sigma 100/200/300 series pacemakers. (Updated modeling for the 2005 subset predicts a failure rate of 3.9% over the remaining device life.)

According to Medtronic, the above problems occurred when the both interconnect wires separate from a hybrid block in the integrated circuit board of the pacemakers. Depending on which hybrid block was affected, one of the above malfunctions will occur. The failure mechanism is similar to the one reported by in a subset of Sigma pacemakers in 2005. The cause of wire separation for the present subset has yet to be determined (For the 2005 subset, the wires were cleaned during manufacturing with a particular cleaning solvent that could potentially reduce the strength of the interconnect wire bond over time). The photo (see the following page), reproduced from the Technical Brief from Medtronic for the 2005 Sigma subset, illustrates the physical problem.

The incidence rate is low. We concur with Medtronic and do not recommend replacement of all affected units. As in our previous communications regarding recalls and safety alerts on implantable devices, we urge you to weigh the incidence and consequence of failure against potential complications with generator replacement.

- Perform an interrogation on your patients with the affected pacemaker and discuss this safety issue with your patients as soon as you can (by August 15, 2009, as suggested by the VA Patient Safety Alert AL09-22).
- Consider device replacement in patients who are totally pacemaker dependent.

- Routine device interrogation in your clinic every 3 months for pacing-dependent patients and every 6 months for the non-dependent patients. Both groups should have trans-telephonic monitoring every 1 month by the Eastern and Western Pacemaker Surveillance Centers.
- Reinforce the importance of follow-up to the patients. Advise patients to seek attention immediately if they experience symptoms attributable to pacemaker failure (e.g., syncope, near-syncope, fatigue or dizziness).
